Manhole Inspection Summary

Manhole # S15GG1028MH

Insp Date: **3/1/07 10:31 AM**

Location Address: **2419 LOYOLA SOUTHWAY**

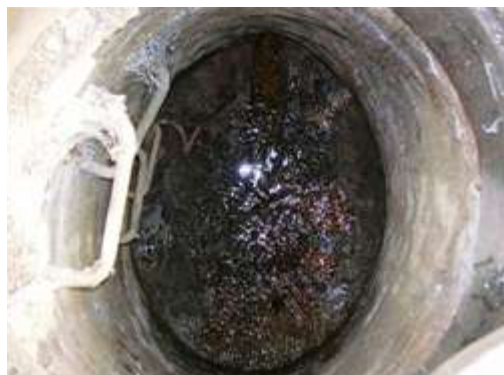
Top View

Channel debris

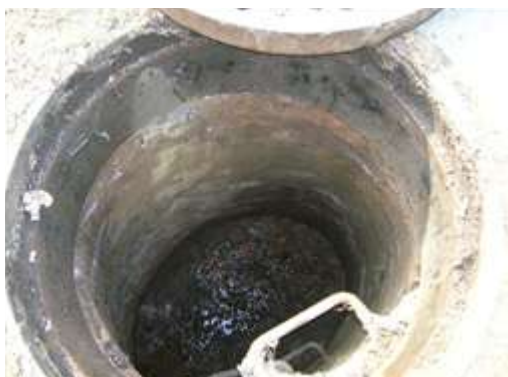
Defect

Frame leaks. Adjustment deterioration, loose brick, and infiltration. Corbel and Barrel infiltration - other side.

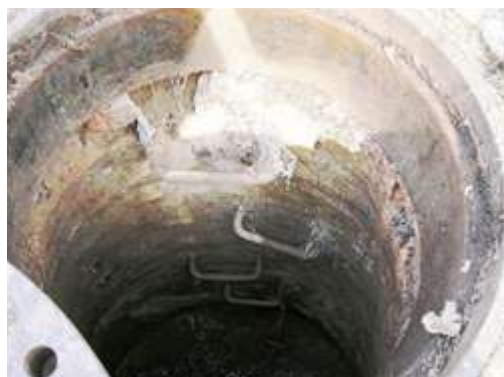
Defect

Frame leaks. Adjustment deterioration, loose brick, and infiltration. Corbel and Barrel infiltration.

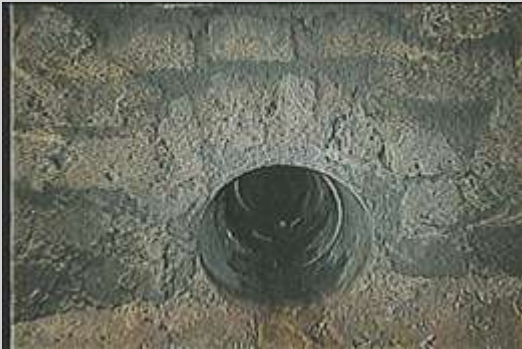
8 in. Circular Gravity Sewer
Pipe Out @ 12 O'Clock

Barrel deterioration and infiltration.
